REVERE COPPER AND BRASS

SITE ASSESSMENT

DETROIT, MICHIGAN

January, 1988

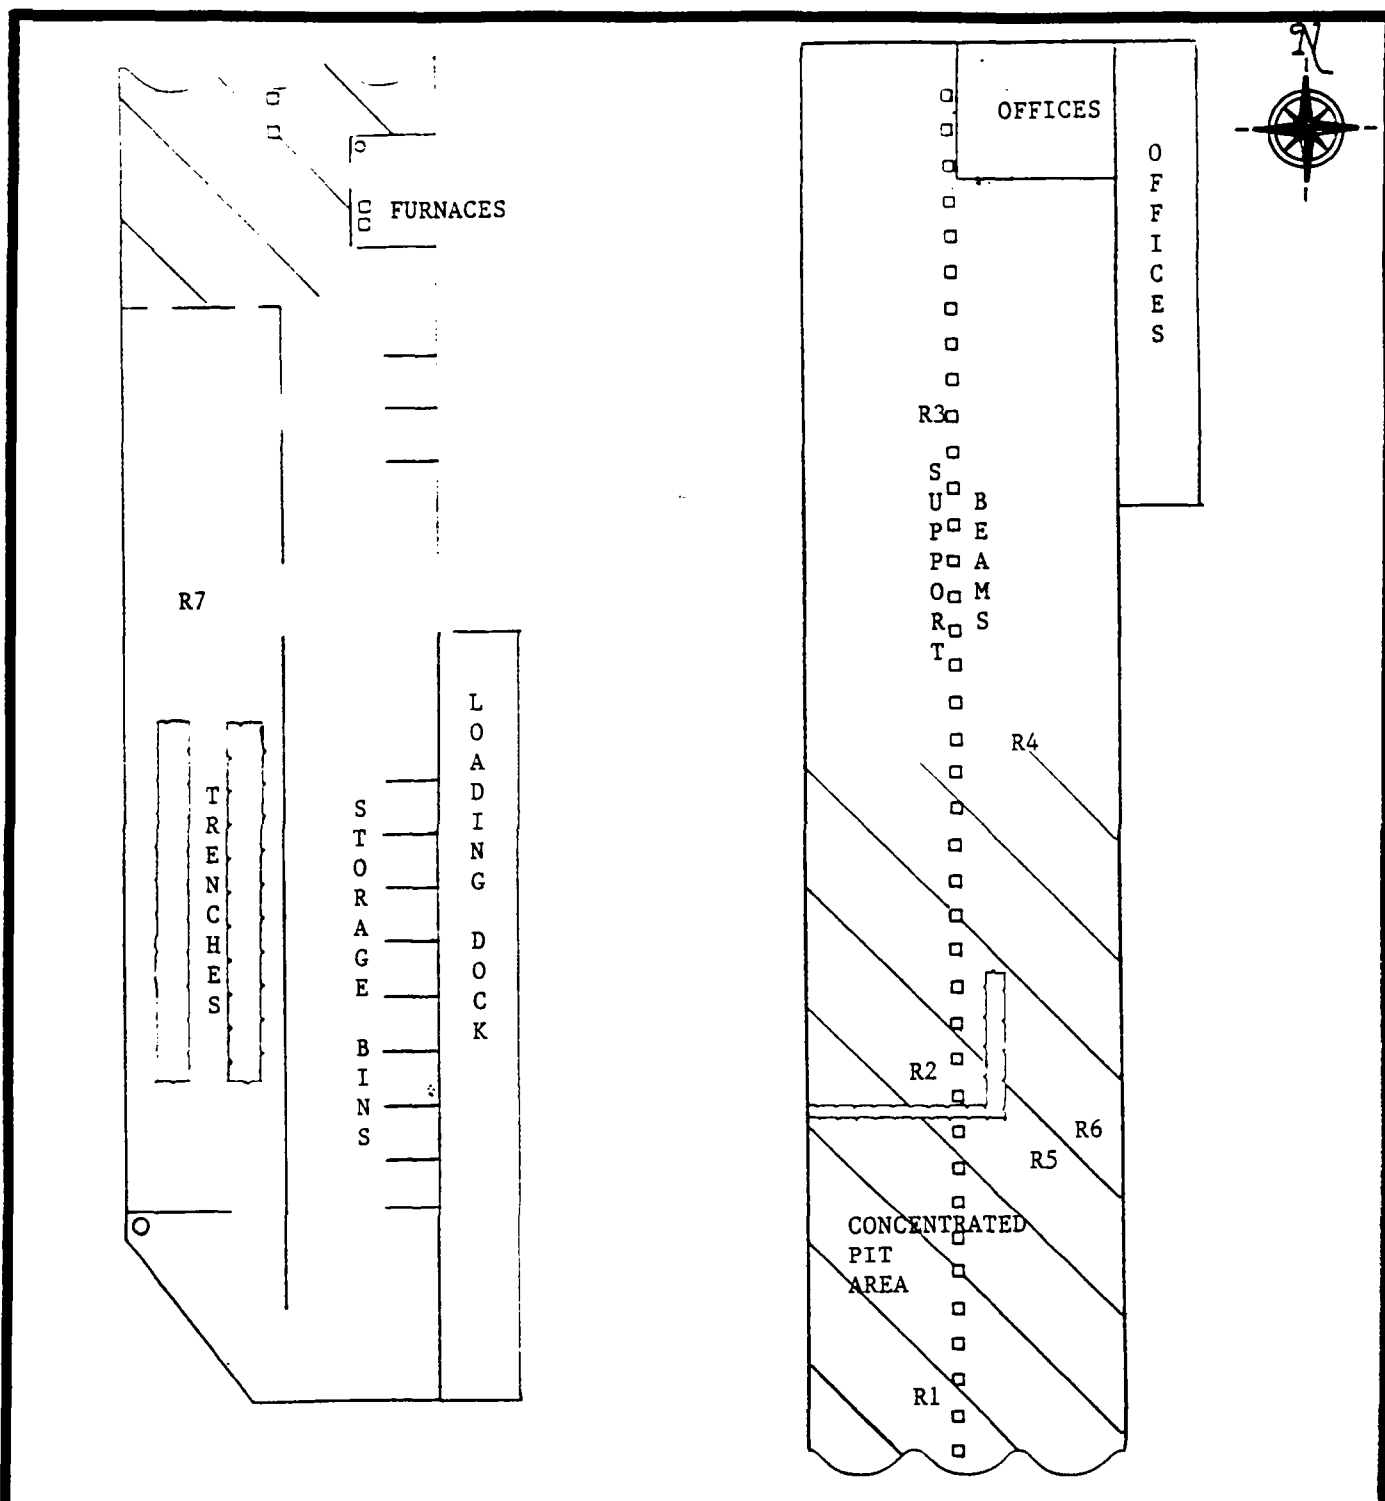
FIGURE 3
 SAMPLING LOCATION MAP
 REVERE COPPER AND BRASS
 DETROIT, MICHIGAN

On November 5, 1987 TAT members Tim Ott and Dan Capone met U.S. EPA On-Scene Coordinator (OSC) Peter Neithercut at the site to collect samples from inside the building. Liquid samples R1 through R6 were collected from various pits and trenches, which were the lowest areas in the building, and appeared to contain most of the floor run-off of oily materials. Inside the building a block of approximately twelve capacitors (approximate volume: 2 gallons/capacitor) was discovered mounted on the wall of an equipment pit. A punctured capacitor was located on the floor above the equipment pit. A soil sample (R7) was collected from the area beneath the punctured capacitor (Figure 3). The samples were analyzed for PCBs under TAT analytical services TDD# 5-8709-L5 by Thermo Analytical, Inc.

The PCB analytical results are summarized in Table 1. All of the liquid samples (R1-R6) were below 6.0 parts per million (ppm). The soil sample (R7) collected directly beneath the punctured capacitor, had an extremely high concentration of Arochlor 1242 (160,000 ppm). The National PCB Spill Clean-up Policy (52FR10680) states that soils contaminated by PCBs greater than 500 ppm are required to be removed until a clean-up level of either 10 ppm or 25 ppm is obtained, dependent upon the spill location.

Because the documented PCB contamination is limited at RCB the TAT does not recommend a removal action conducted by U.S. EPA at this time. However, the current owner of the site (City of Detroit CEDD) should be notified of both the PCB contamination and potential for further releases. CEDD should be held responsible for removing all capacitors, and performing an effective cleanup of the contaminated area. The National PCB Spill Cleanup Policy should be used as the appropriate clean-up standard. The CEDD should also conduct a more extensive assessment of the building to assure that no additional capacitors are present on-site. In addition, the suspected asbestos problem should be referred to the Regional Air Pollution Control Agency to confirm the presence of asbestos and take appropriate actions. If the City of Detroit CEDD is unwilling or unable to take responsibility for a removal action, the TAT recommends that the site be referred to the Michigan Department of Natural Resources for further action under Michigan Act 307.

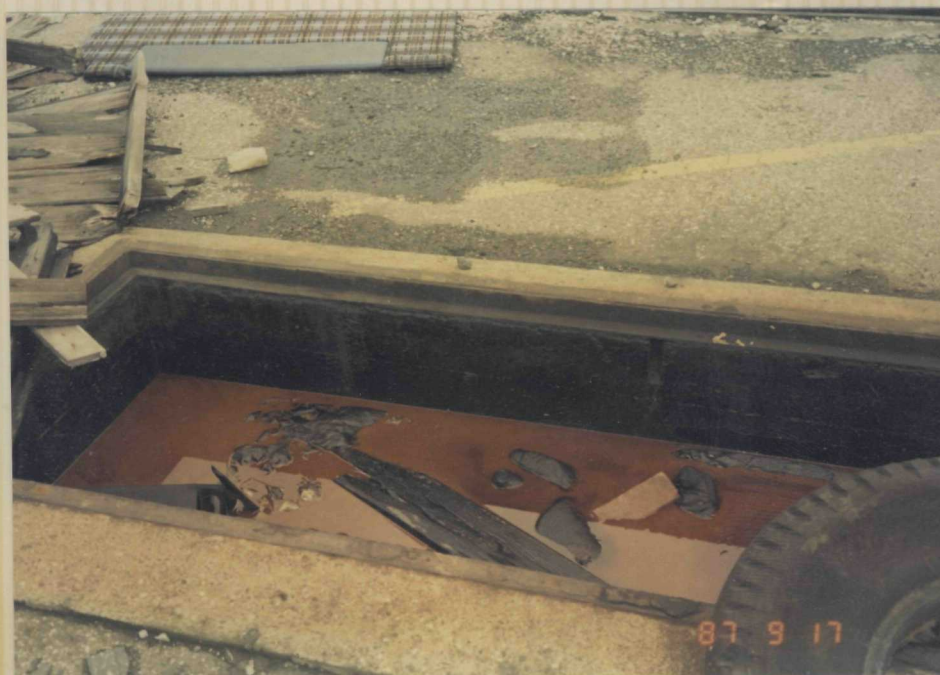
PHOTOGRAPH NUMBER: 8 DIRECTION: E TIME: PM

SUBJECT: OUTSIDE PIT NEAR BUILDING MIDSECTION.

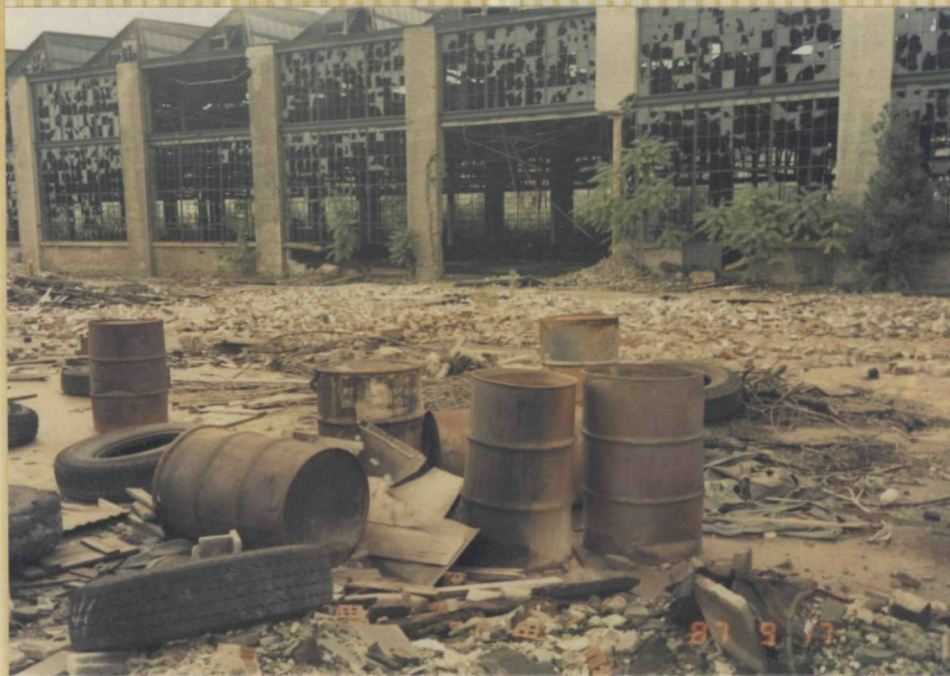
SITE: REVERE COPPER AND BRASS DETROIT, MICH DATE: 9/17/87
 PHOTOGRAPH NUMBER: 9 DIRECTION: W TIME: PM
 CAMERA: OLYMPUS INFINITY SERIAL NUMBER 1217123
 PHOTOGRAPHER: T. OTT 710 WITNESS: M. TURNBULL
 SUBJECT: DRUMS NEAR BUILDING'S MIDSECTION

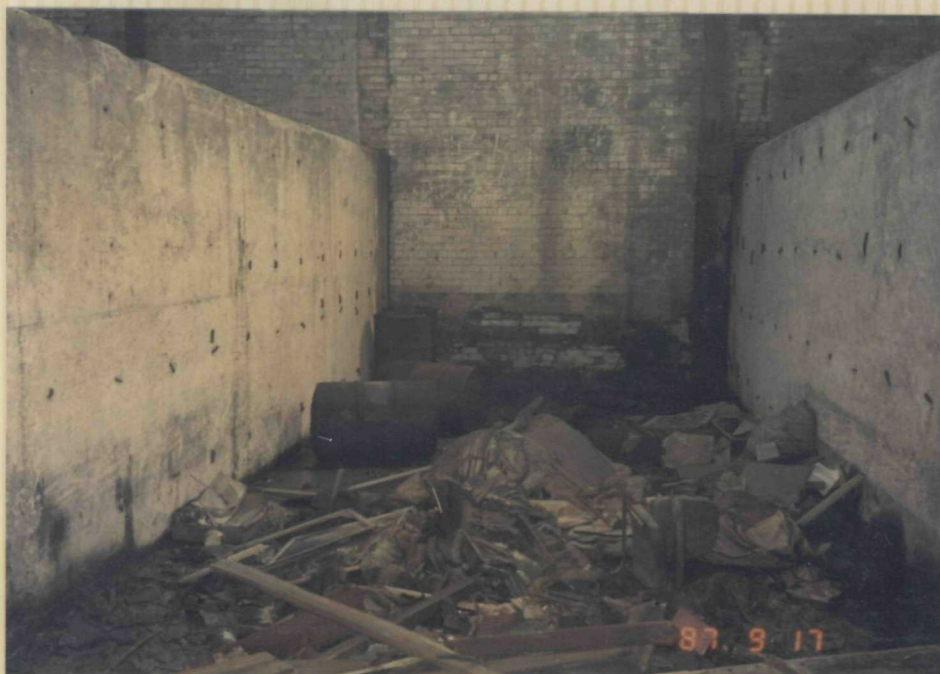
PHOTOGRAPH NUMBER: 16 DIRECTION: E TIME: PM

SUBJECT: DRUMS/WASTE IN A STORAGE BIN

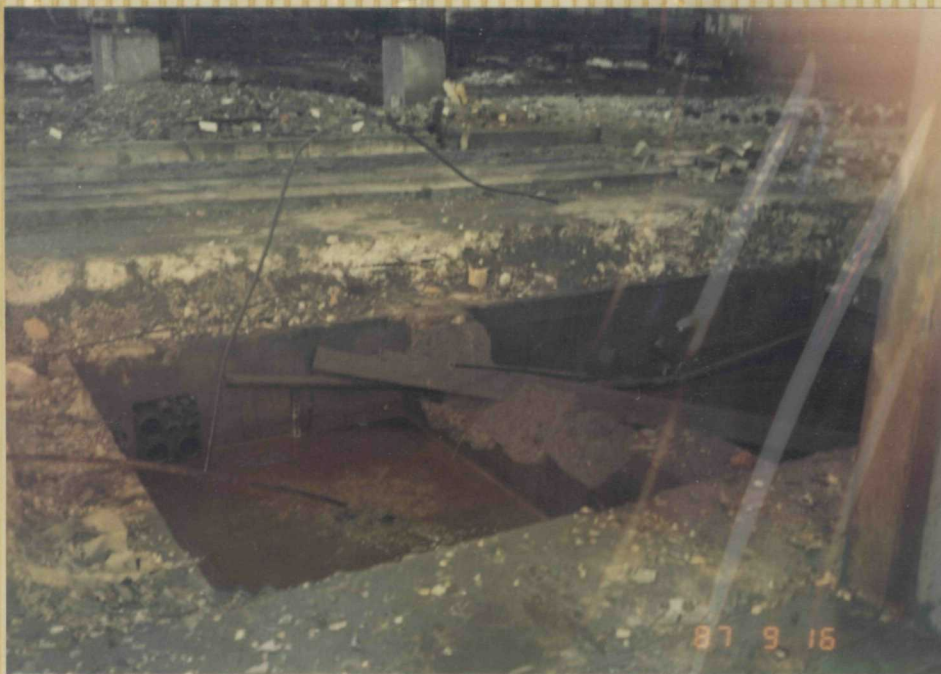
PHOTOGRAPH NUMBER: 17 DIRECTION: W TIME: PM

SUBJECT: MACHINERY PIT OUTSIDE STORAGE BIN

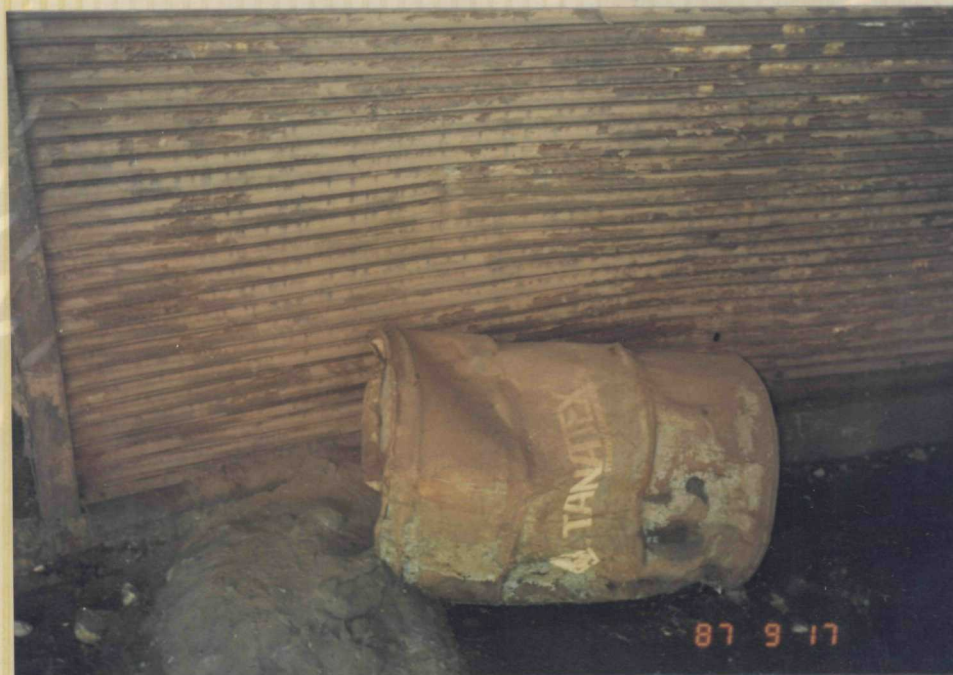
PHOTOGRAPH NUMBER: 18 DIRECTION: W TIME: PM

SUBJECT: DRUM ALONG SOUTHWEST WALL

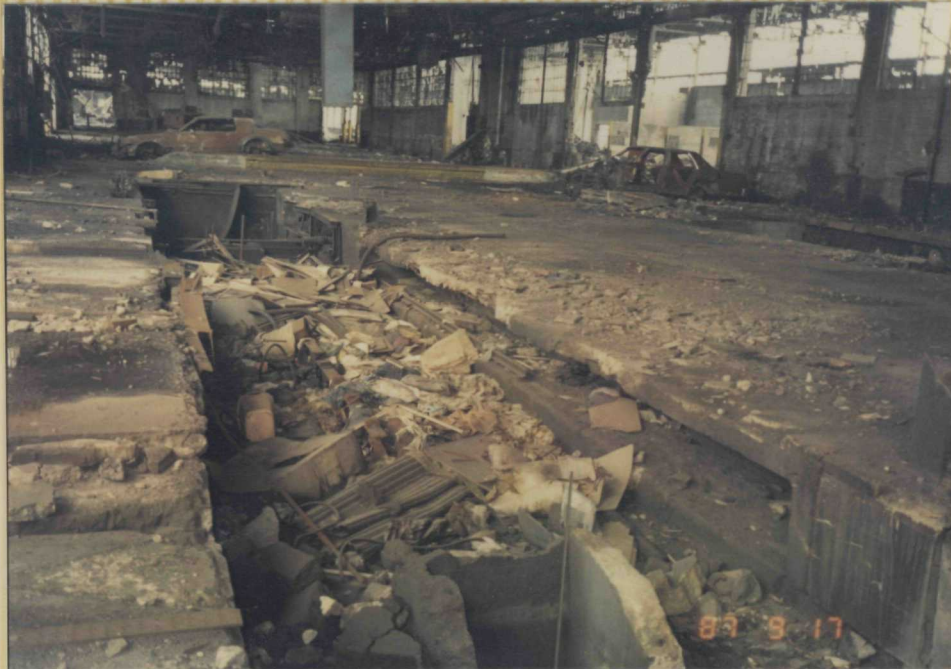
SITE: REVERE COPPER AND BRASS DETROIT, MICH DATE: 9/17/87
 PHOTOGRAPH NUMBER: 19 DIRECTION: N TIME: PM
 CAMERA: OLYMPUS INFINITY SERIAL NUMBER 1217123
 PHOTOGRAPHER: T. OTT 780 WITNESS: M. TURNBULL
 SUBJECT: MACHINERY PIT IN REAR OF BUILDING

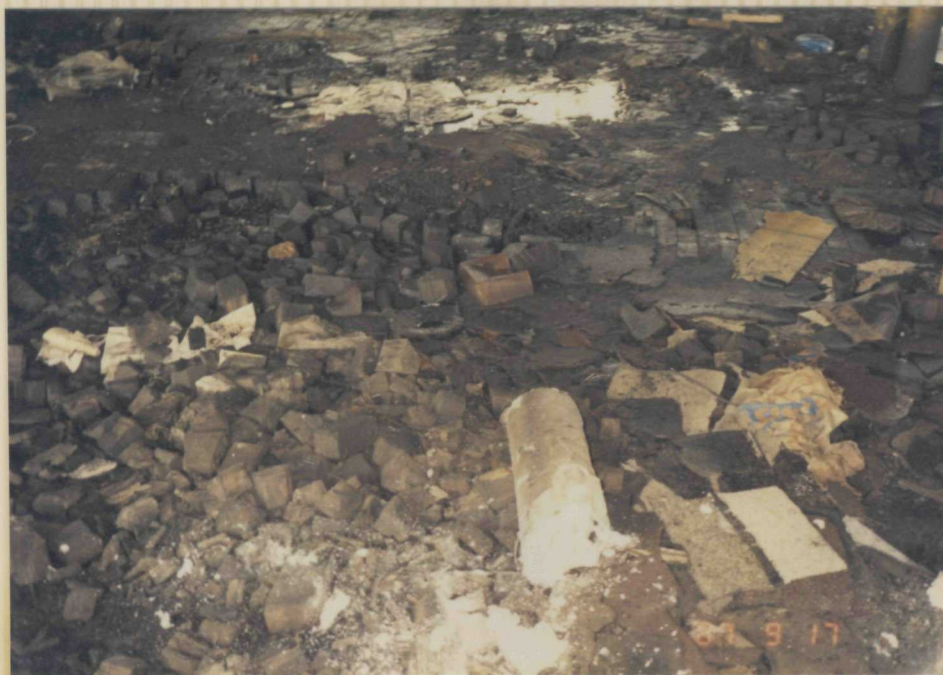
ground levels were detected, as monitored by the photoionization detector, combustible gas indicator, and radiation meter. Inside the building, there were numerous equipment mounting pits which contained water, oil, and various solid waste materials. Several areas where suspected asbestos pipe wrapping was present were identified. Inside the building, an individual was removing metal from the building's support system with a cutting torch. In addition, the TAT documented several sport fishermen on the RCB property waterfront.

SITE: REVERE COPPER AND BRASS DETROIT, MICH DATE: 9/17/87
 PHOTOGRAPH NUMBER: 20 DIRECTION: W TIME: PM
 CAMERA: OLYMPUS INFINITY SERIAL NUMBER 1217123
 PHOTOGRAPHER: T. OTT 780 WITNESS: M. TURNBULL
 SUBJECT: FALLEN ASBESTOS PIPE WRAP IN REAR OF BUILDING

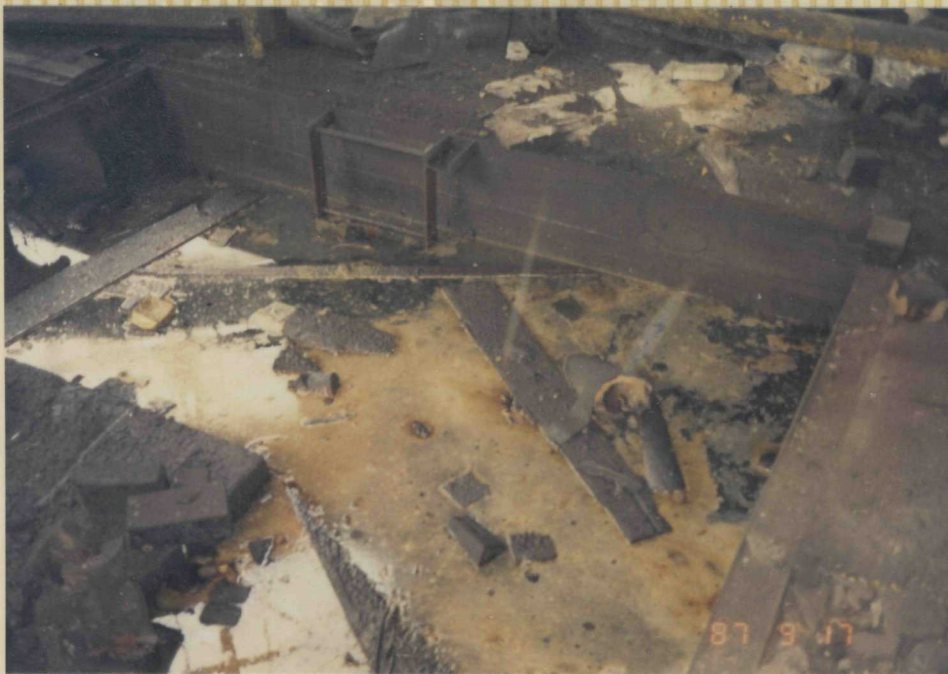
PHOTOGRAPH NUMBER: 21 DIRECTION: N TIME: PM

SUBJECT: MACHINERY PIT IN MIDSECTION OF BUILDING

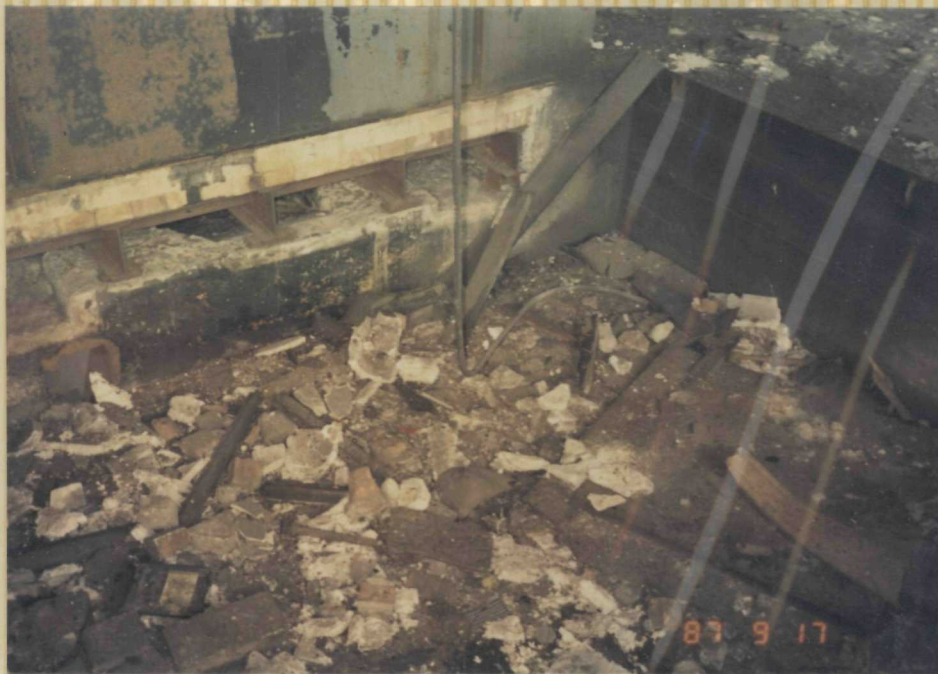
PHOTOGRAPH NUMBER: 25 DIRECTION: W TIME: PM

SUBJECT: ASBESTOS PIPE WRAP IN FURNACE PIT

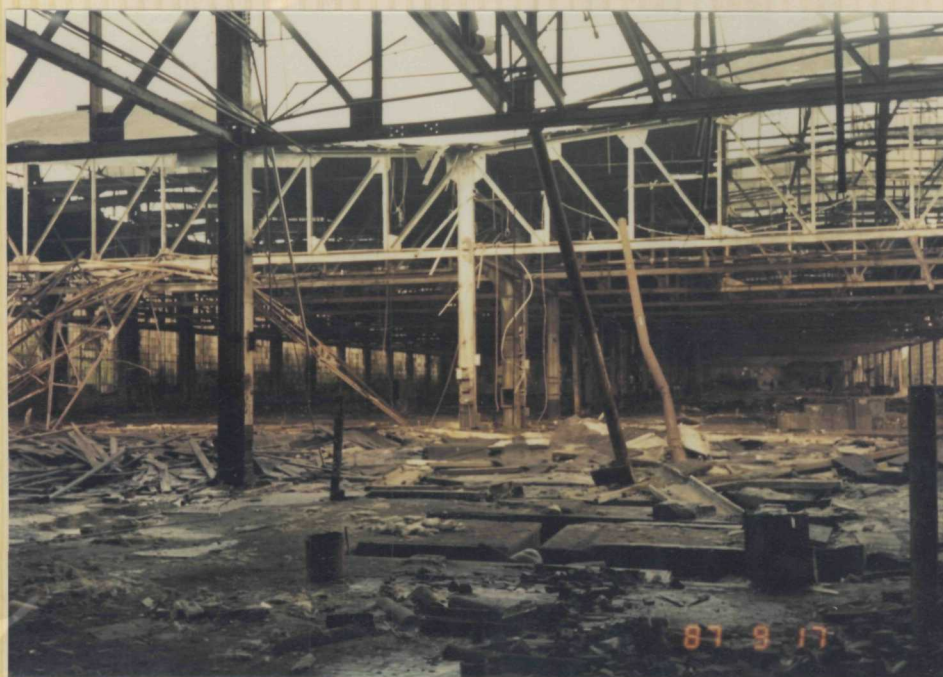
PHOTOGRAPH NUMBER: 26 DIRECTION: N TIME: PM

The site was suspected of having elevated levels of polychlorinated biphenyls (PCB) because of RCB's handling of scrap copper. The main building is located on the western edge of the property. In the midsection of the building, the roof has collapsed leaving a gap of approximately forty feet. The area adjacent to and east of the building is a zone of scattered demolition debris where extensions to the RCB building once stood. There is a large diked storage tank on the east edge of the demolition debris zone. Four empty offices and support buildings are located on the site. Also, throughout the site, there are considerable amounts of scattered solid waste such as automobiles, mattresses, and refuse.

SUBJECT: FALLEN SECTION OF ROOF IN MIDDLE OF BUILDING

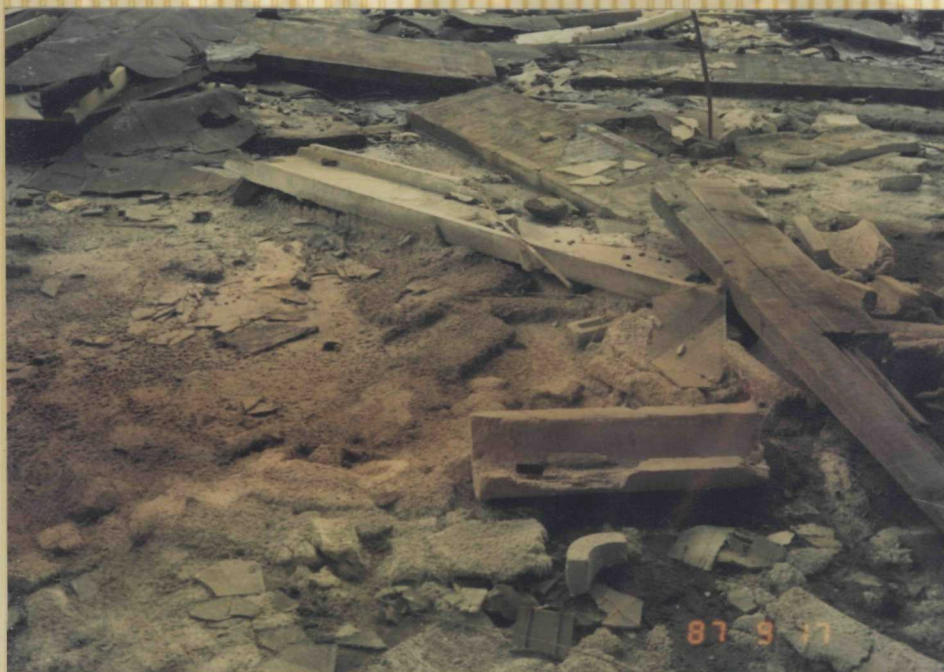
PHOTOGRAPH NUMBER: 27 DIRECTION: N TIME: PM

SUBJECT: ASBESTOS PIPE WRAP IN MIDSECTION OF BUILDING

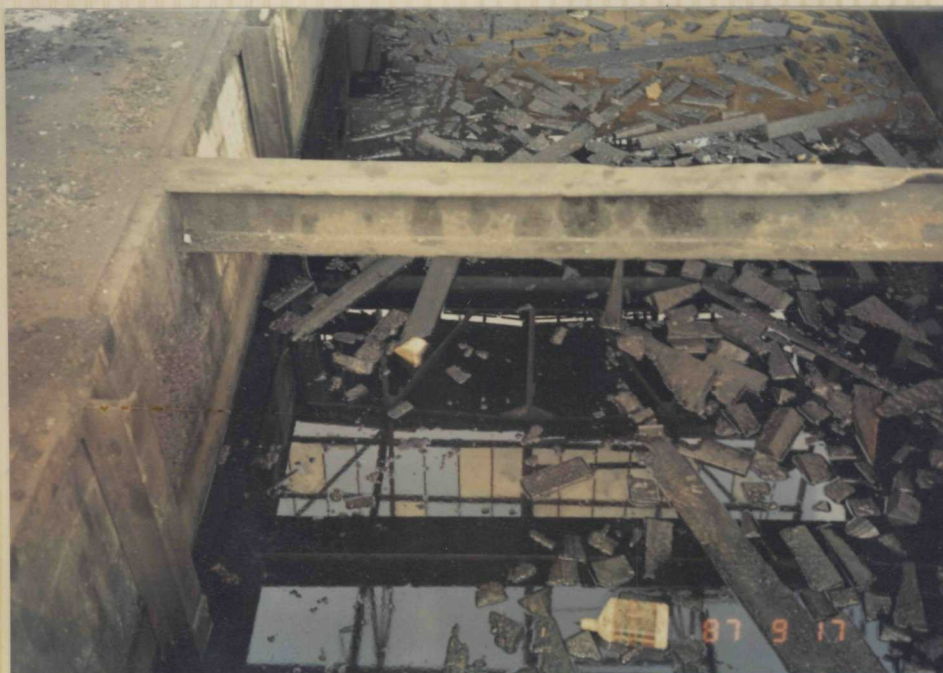
PHOTOGRAPH NUMBER: 28 DIRECTION: N TIME: PM

SUBJECT: MACHINERY PIT IN MIDSECTION OF BUILDING

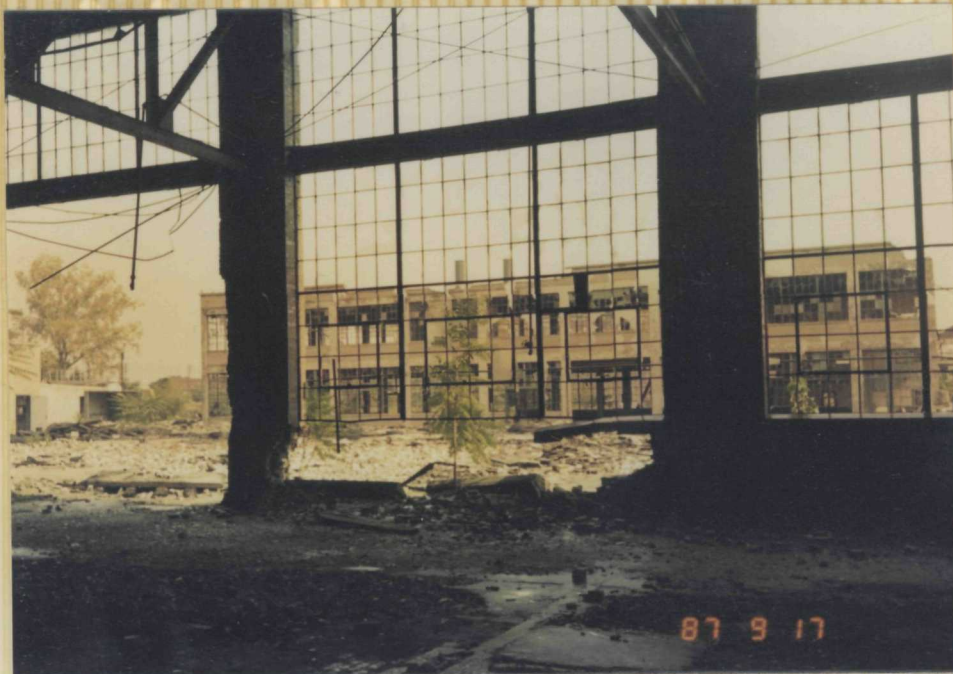
SITE: REVERE COPPER AND BRASS DETROIT, MICH DATE: 9/17/87
 PHOTOGRAPH NUMBER: 31 DIRECTION: E TIME: PM
 CAMERA: OLYMPUS INFINITY SERIAL NUMBER 1217123
 PHOTOGRAPHER: T. OTT 70 WITNESS: M. TURNBULL
 SUBJECT: BROKEN FOUNDATION IN MIDSECTION OF BUILDING
